## **Investigation into the *in situ* thermal performance of 2 static caravans - Assessing the change in heat loss behaviour due to thermally superior replacement windows.**

**Client:** Camden Group  
Steeple Road Industrial Estate  
Antrim  
Northern Ireland  
BT41 1AB

**Site Address:** Units C05 & C10, Holly Bank  
Blue Dolphin Holiday Park  
Filey  
North Yorkshire  
YO14 9PU

April, 2015

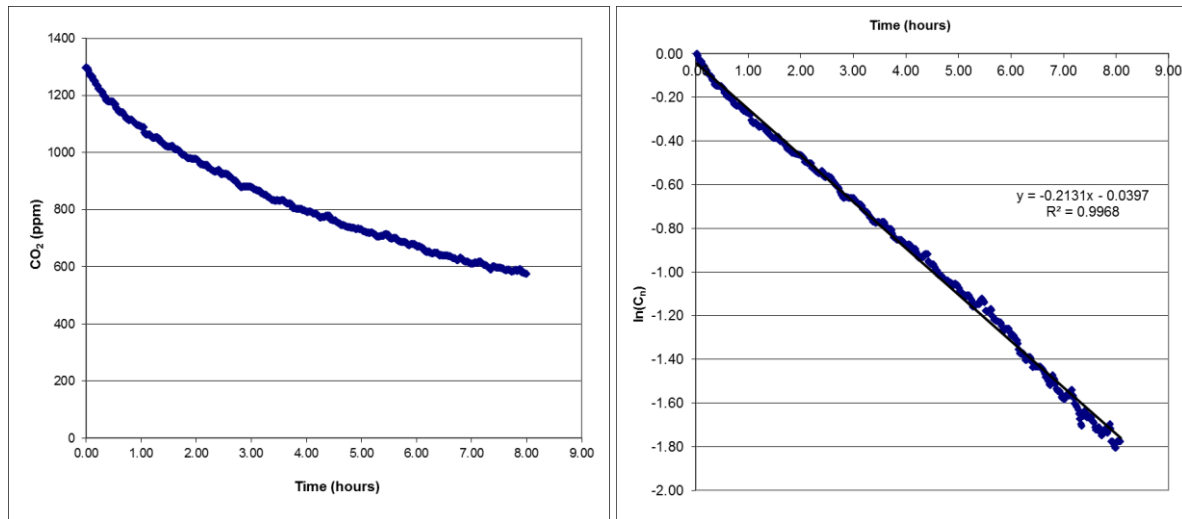
Figure 5: CO<sub>2</sub> decay curves for caravan CO5 stage 1 test

level). The actual air change rate was then determined using the CO<sub>2</sub> decay method described within Roulet and Foradini (2002). The results obtained using this method, illustrated by Figure 5 and Table 4, suggest that in the test caravans a figure of n/40 is more applicable to approximate the actual ventilation rate during the tests. This figure has also been used to determine the heat loss attributable to ventilation and has been used in subsequent energy calculations contained within this report (for instance, see Table 7).

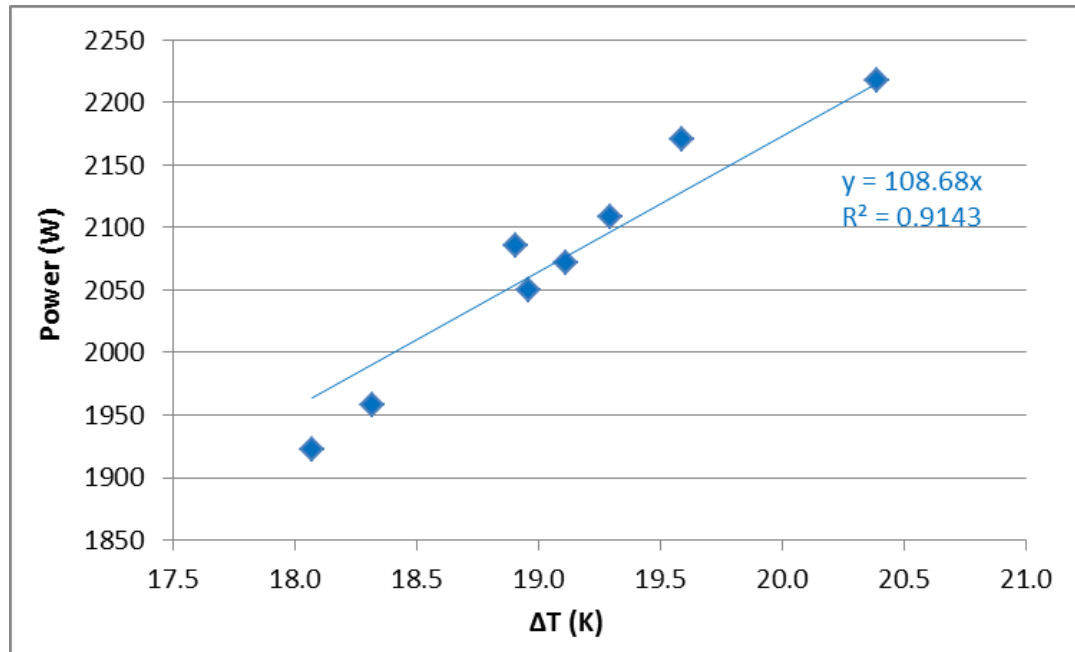
Figure 8: Coheating test 1 analysis for caravan C5 (regression forced through origin)

Figure 8 provides the coheating analysis of caravan C05 during test period 1. The coheating test produced an estimate of the HLC of  $108.7 (\pm 0.5)$  W/K (slope of the regression line). The low thermal mass of the caravan is evident by the strong relationship between mean hourly power demand and  $\Delta T$  ( $r^2$  of 0.91). This relationship provides confidence that reasonable estimate of the HLC can be obtained over a short time period.

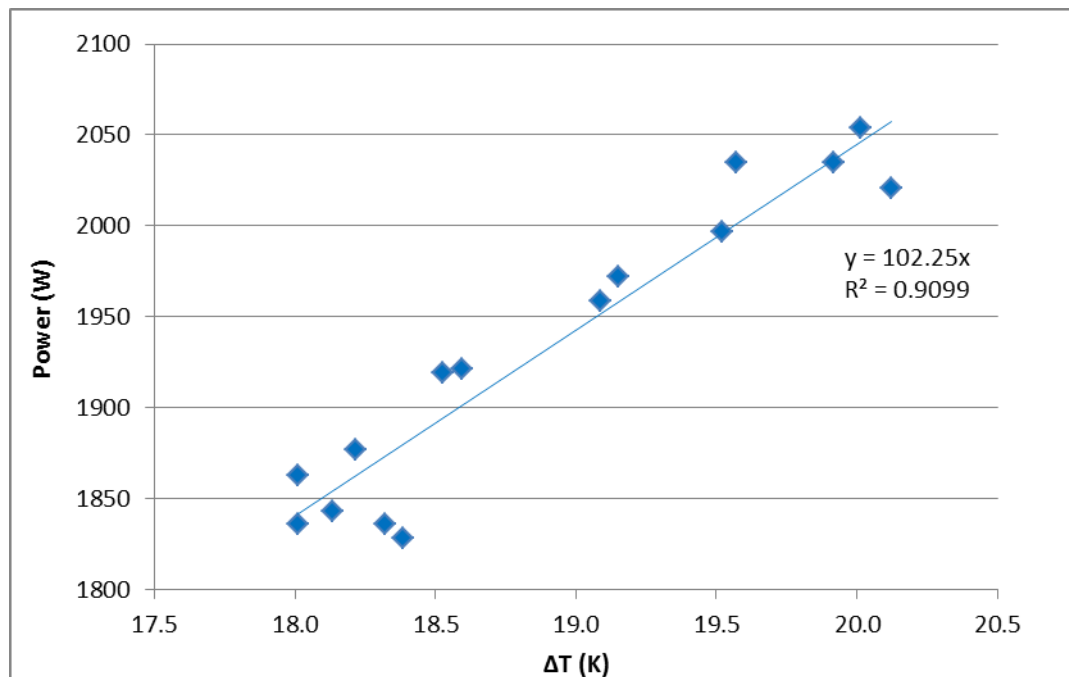
Figure 11: Coheating test 2 analysis for caravan C05 (regression forced through origin)

Figure 11 provides the coheating analysis of caravan C05 during test period 2. It is clear that there is a strong relationship between the mean hourly power demand and  $\Delta T$  ( $r^2$  of 0.91). The coheating test produced an estimate of the HLC of 102.3 ( $\pm 0.3$ ) W/K. This represents a reduction in HLC of 6.5 W/K (5.9%) from test period 1. As the airtightness of the caravan remained almost unchanged following test period 1, this reduction can primarily be attributed to the installation of the replacement windows.

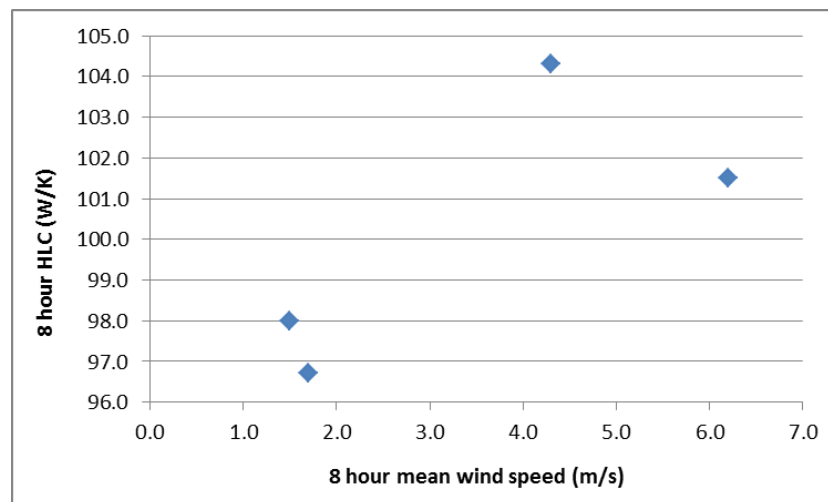
Figure 14: Wind speed vs. nightly HLC for caravan C05 during test period 3

Figure 14 shows the relationship between nightly HLC estimates and mean wind speed measured<sup>1</sup> during the test period. The higher wind speed measured during night 1 and night 3 correlate with the higher HLCs measured and the poorer relationship between power input and  $\Delta T$  measured (lower  $r^2$  value). It is reasonable to assume that the many ventilation points through the caravan structure mean that it is susceptible to increased ventilation heat loss and wind-washing of the insulation during periods of high wind speeds.

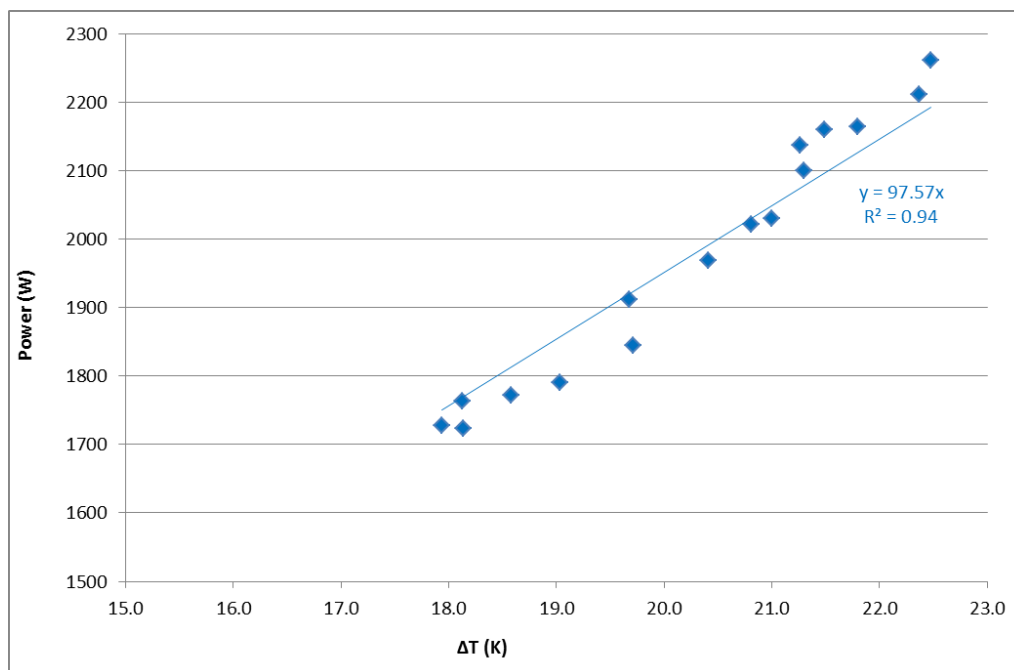
Figure 16: Coheating test 3 analysis for caravan C05 (regression forced through origin)

Figure 16 provides the coheating analysis of caravan C05 during test period 3 using data obtained from night 2 and night 4 only. The coheating test produced an estimate of the HLC of 97.6 ( $\pm 0.6$ ) W/K. This represents a reduction in HLC of 11.1 W/K (11.4%) from test period 1. There is a high degree in confidence with the HLC estimate due to the very strong correlation between power input and  $\Delta T$  ( $r^2$  of 0.94). Unfortunately, it was not possible to measure change in airtightness that may have occurred following the installation of the new door. Assuming that the airtightness of C05 did not significantly change when the door was replaced, the reduction in HLC from test period 1 can primarily be attributed to the installation of the replacement windows and door.

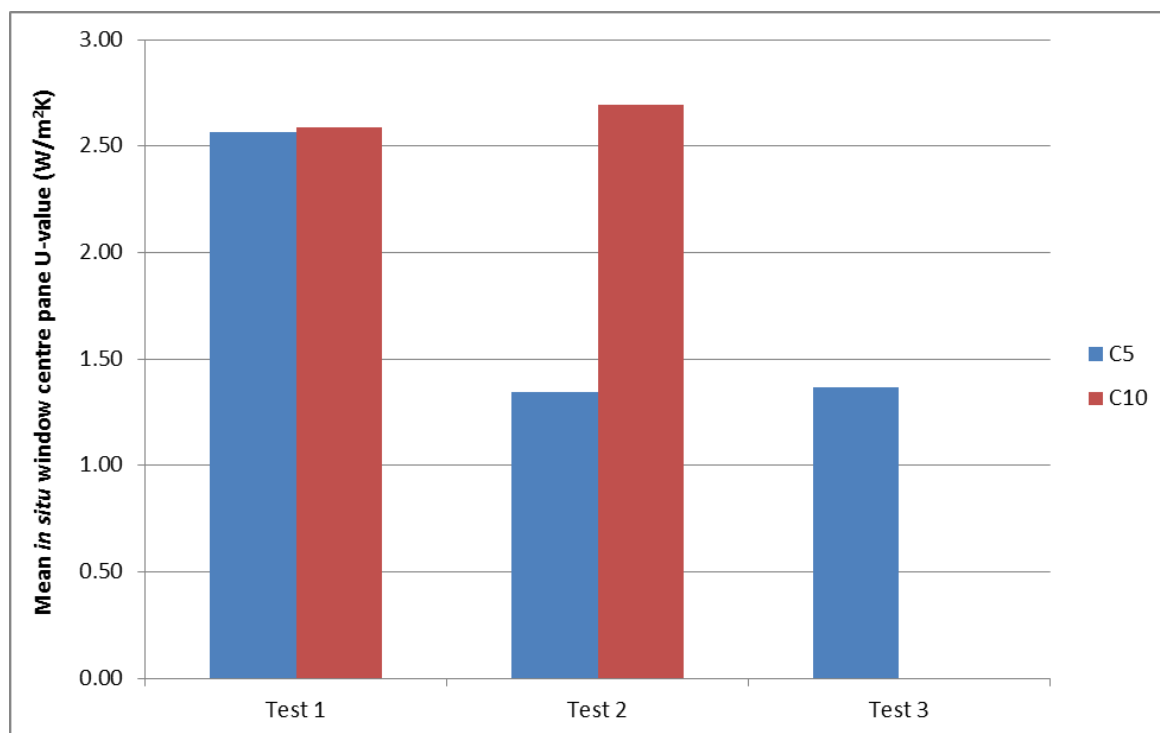
Figure 18: Mean *in situ* window centre pane U-value for each caravan during the 3 test periods (windows only).

There was a high level of consistency between *in situ* glazing centre pane U-values measured across both caravans (mean 2.60 W/m<sup>2</sup>K, SD 0.06 W/m<sup>2</sup>K) in test period 1. The *in situ* U-values of non-glazed thermal elements in each caravan remained reasonably consistent across each of the test periods, this supports the assertion made in the coheating analysis that the reduction in HLC of caravan C05 is primarily due to the installation of replacement glazing and door. In addition, the mean *in situ* window centre pane U-value in caravan C05 reduced from 2.57 W/m<sup>2</sup>K to 1.37 W/m<sup>2</sup>K following the installation of the replacement windows. Figure 18 illustrates the reduction in mean *in situ* window centre pane U-value that was measured across the test periods.

The installation of the replacement windows in caravan C05 resulted in a reduction of mean *in situ* window centre pane U-value (for the 4 windows and door investigated) from 2.57 W/m<sup>2</sup>K to 1.37 W/m<sup>2</sup>K.
